# Manhole Inspection Summary

Manhole # S15M\_\_010MH

Insp Date: **4/4/08 9:37 AM**

**Location** Address: **2608 maempel la**

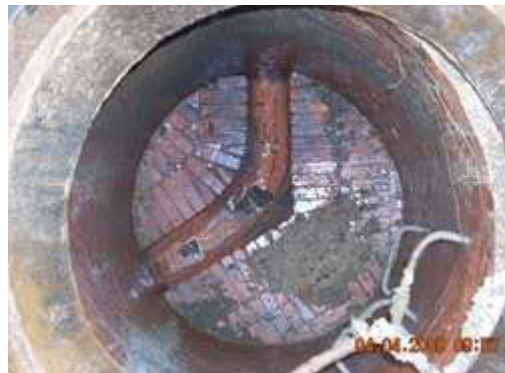
Top View

Frame offset, 1"

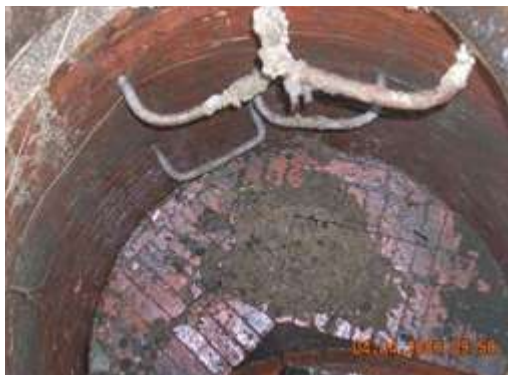
misc

bench debris

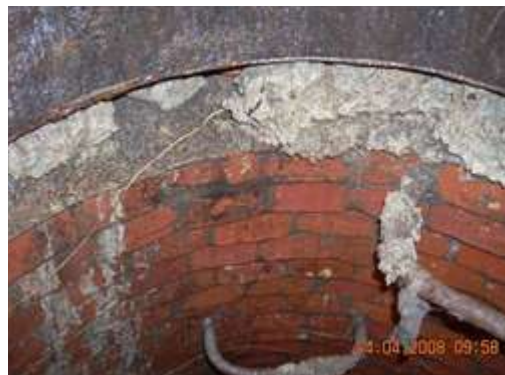
Defect 1

Condition: ☐ Sound ☐ Cracked ☒ **Root Intrusion** ☐ Loose Brick ☒ **Deteriorated**

Infiltration: ☐ None ☒ **Joint** ☐ Cracks ☐ Mortar ☐ Roots ☐ Wall

deteriorated chimney, roots at chimney/frame joint

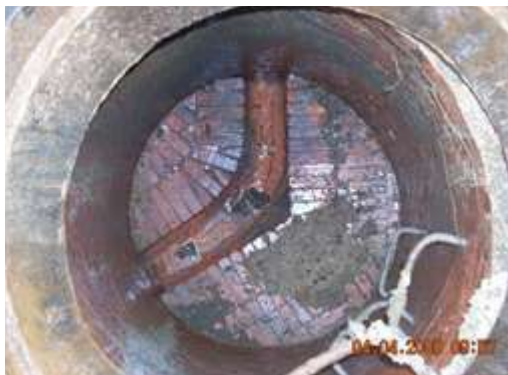
Defect 2

Frame offset, 1"

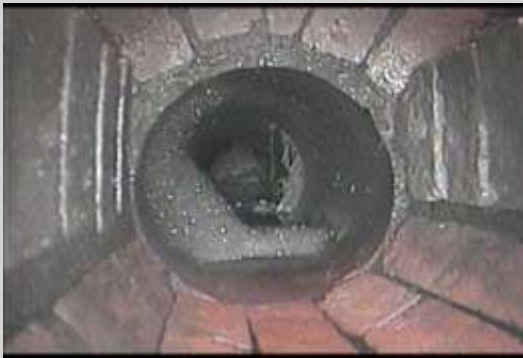
12 O'Clock Outflow

8 in. Circular Gravity Sewer  
Pipe Out @ 12 O'Clock

Pipe Height: **8.4** (in.) Rod and Bar (Angled)  
Pipe Material: **Clay** ☐ Pipe Lined  
Invert Depth: **7.43** (ft.) Flow Characteristics: **Slow**  
Deposits: ☒ None ☐ Mud ☐ Sludge ☐ Debris ☐ Grease  
Silt Depth: **0** (in.) Deposits Extent:  
Infiltration: **None** Pipe Seal Cond: **Sound**

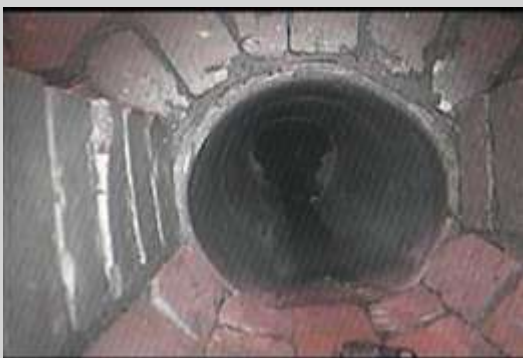
8 O'Clock Inflow

8 in. Circular Gravity Sewer  
Pipe In @ 8 O'Clock

Pipe Height: **8.4** (in.) Rod and Bar (Angled)  
Pipe Material: **Clay** ☐ Pipe Lined  
Invert Depth: **7.27** (ft.) Flow Characteristics: **Slow**  
Deposits: ☒ None ☐ Mud ☐ Sludge ☐ Debris ☐ Grease  
Silt Depth: **0** (in.) Deposits Extent:  
Infiltration: **None** Pipe Seal Cond: **Sound**
